Community based landslide risk reduction: evidence and challenges

Prof. Malcolm G Anderson

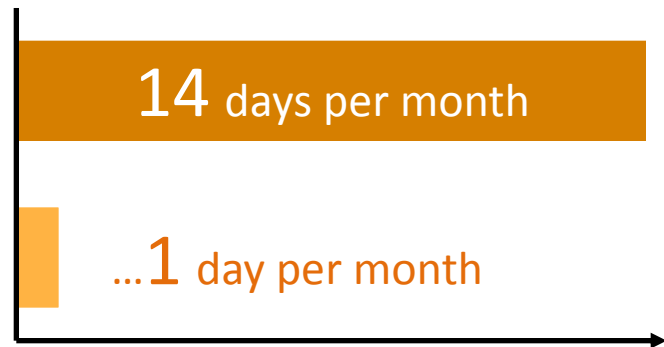
But, roof guttering + proper surface drainage reduce the level of soil saturation to...

Days per month soil is saturated

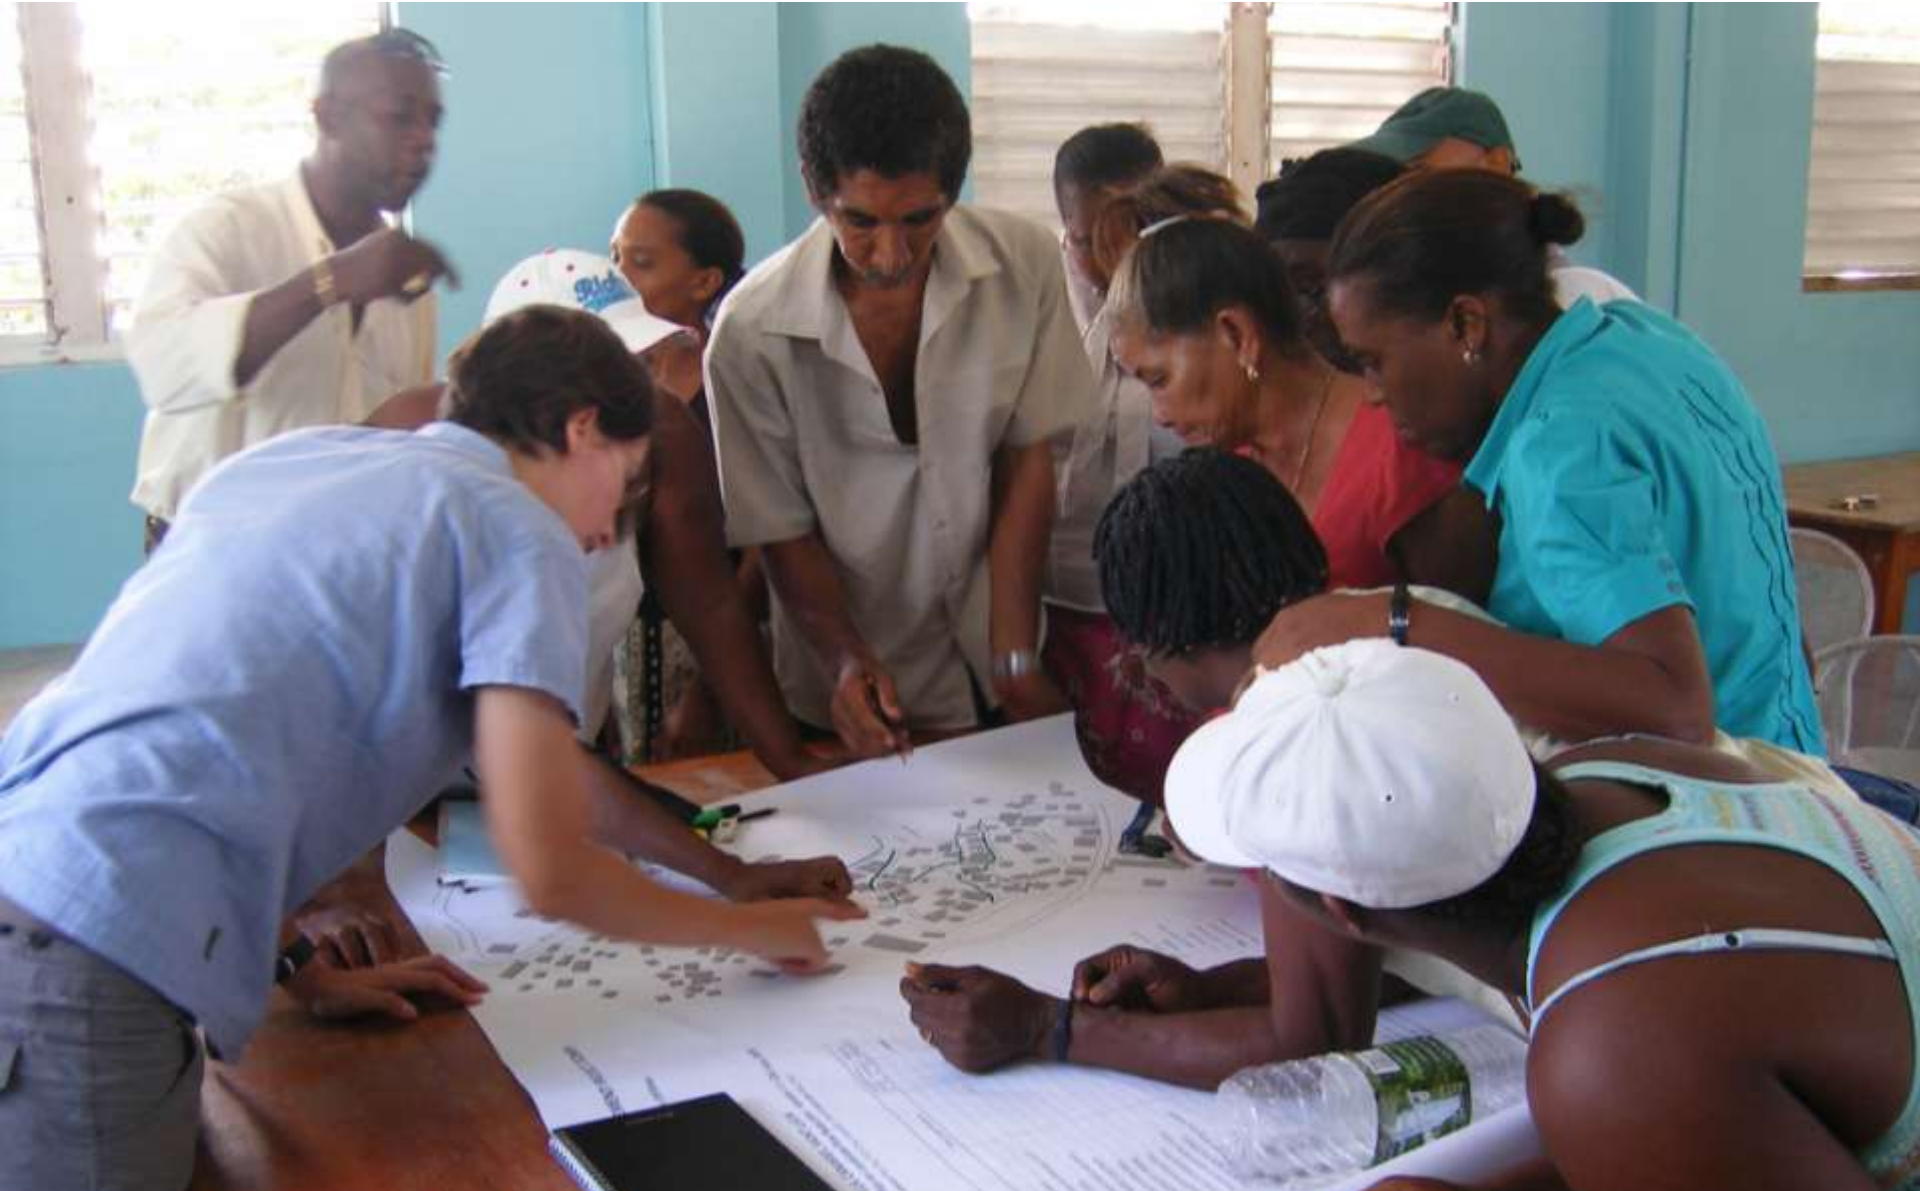
GPS WAYPOINT NOTES

WP	northing	easting	elevation	notes
001	12.989055	-61.25171	119	drainage from field onto footpath
002*	12.989066	-61.250972	126	Marcia Bynoe: front corner of balcony/step with view of relict landslide scarp directly north (bearing 0°)
003*	12.989085	-61.250982	125	(duplicate waypoint... see WP 002 above)
004*	12.988888	-61.251024	126	concrete steps
005*	12.988888	-61.251025	126	(duplicate waypoint... see WP 004 above)
006	12.988466	-61.250416	130	Zita Bynoe: Pink House. Cracking of new extension built on fill material: water entering house
007	12.988392	-61.250952	115	bedrock outcropping
008	12.988435	-61.251088	107	bedrock outcropping - looking downslope on route of flood
009	12.988755	-61.251157	111	Harold James: bedrock outcropping on earth footpath below house
010	12.988776	-61.251424	102	concrete tank by earth footpath
011	12.989105	-61.251446	110	50m from start of concrete path (WP 014); 30m from WP 001

012	12.989021	-61.251311	113	30m from WP 011; 30m from WP 005 (concrete steps)
013	12.989034	-61.251276	114	(duplicate waypoint... see WP 012 above)
014	12.988825	-61.251848	96	start of concrete path
015	12.988563	-61.251751	85	new concrete path with retaining wall and no drain - water floods over top of path onto houses downslope
016	12.988264	-61.25155	74	Bouton Compton: gulleying between water tank and upslope neighbour's retaining wall. spongy level reading up natural drainage route @ = 36"
017	12.98752	-61.251375	53	Anita Davis: next to drainage route - flooding of yard
018	12.98759	-61.251323	56	4-inch block up-stand required to prevent water flowing off road into houses below (distance = 40m)
019	12.987053	-61.251048	52	flooding from road to back of shop - road blocks with debris after heavy rains (source = natural drainage route flowing from east of WP 006)
020	12.989921	-61.251393	41	natural drainage from road (WP 019)

021	12.986792	-61.251507	36	culvert under road
022	12.986901	-61.251674	39	path by drainage route
023	12.987656	-61.251221	41	gulley - floods onto road
024	12.98842	-61.251967	69	Ulaana Hazell: water floods back of house
025	12.98812	-61.251994	68	boundary between Coffal Williams and Guide household - possible route for drain. Flooding at back of William's house. front yard concrete cracking. Neighbours downslope (Imelda Hazell) started excavation for retaining wall.
026	12.988057	-61.251858	63	Ouida: boundary with Williams. possible route for drain.
027	12.988396	-61.251477	47	Compton: corner of water tank - gulleying in heavy rains. Possible route for drain.
028	12.988451	-61.251424	57	new concrete path with no drainage (see WP 015). Possible route for drain across path - would require breaking up and re-construction of section of path for culvert.
029	12.988742	-61.250943	101	possible route of intercept drain following earth path

030	12.988755	-61.250859	103	possible route of intercept drain following earth

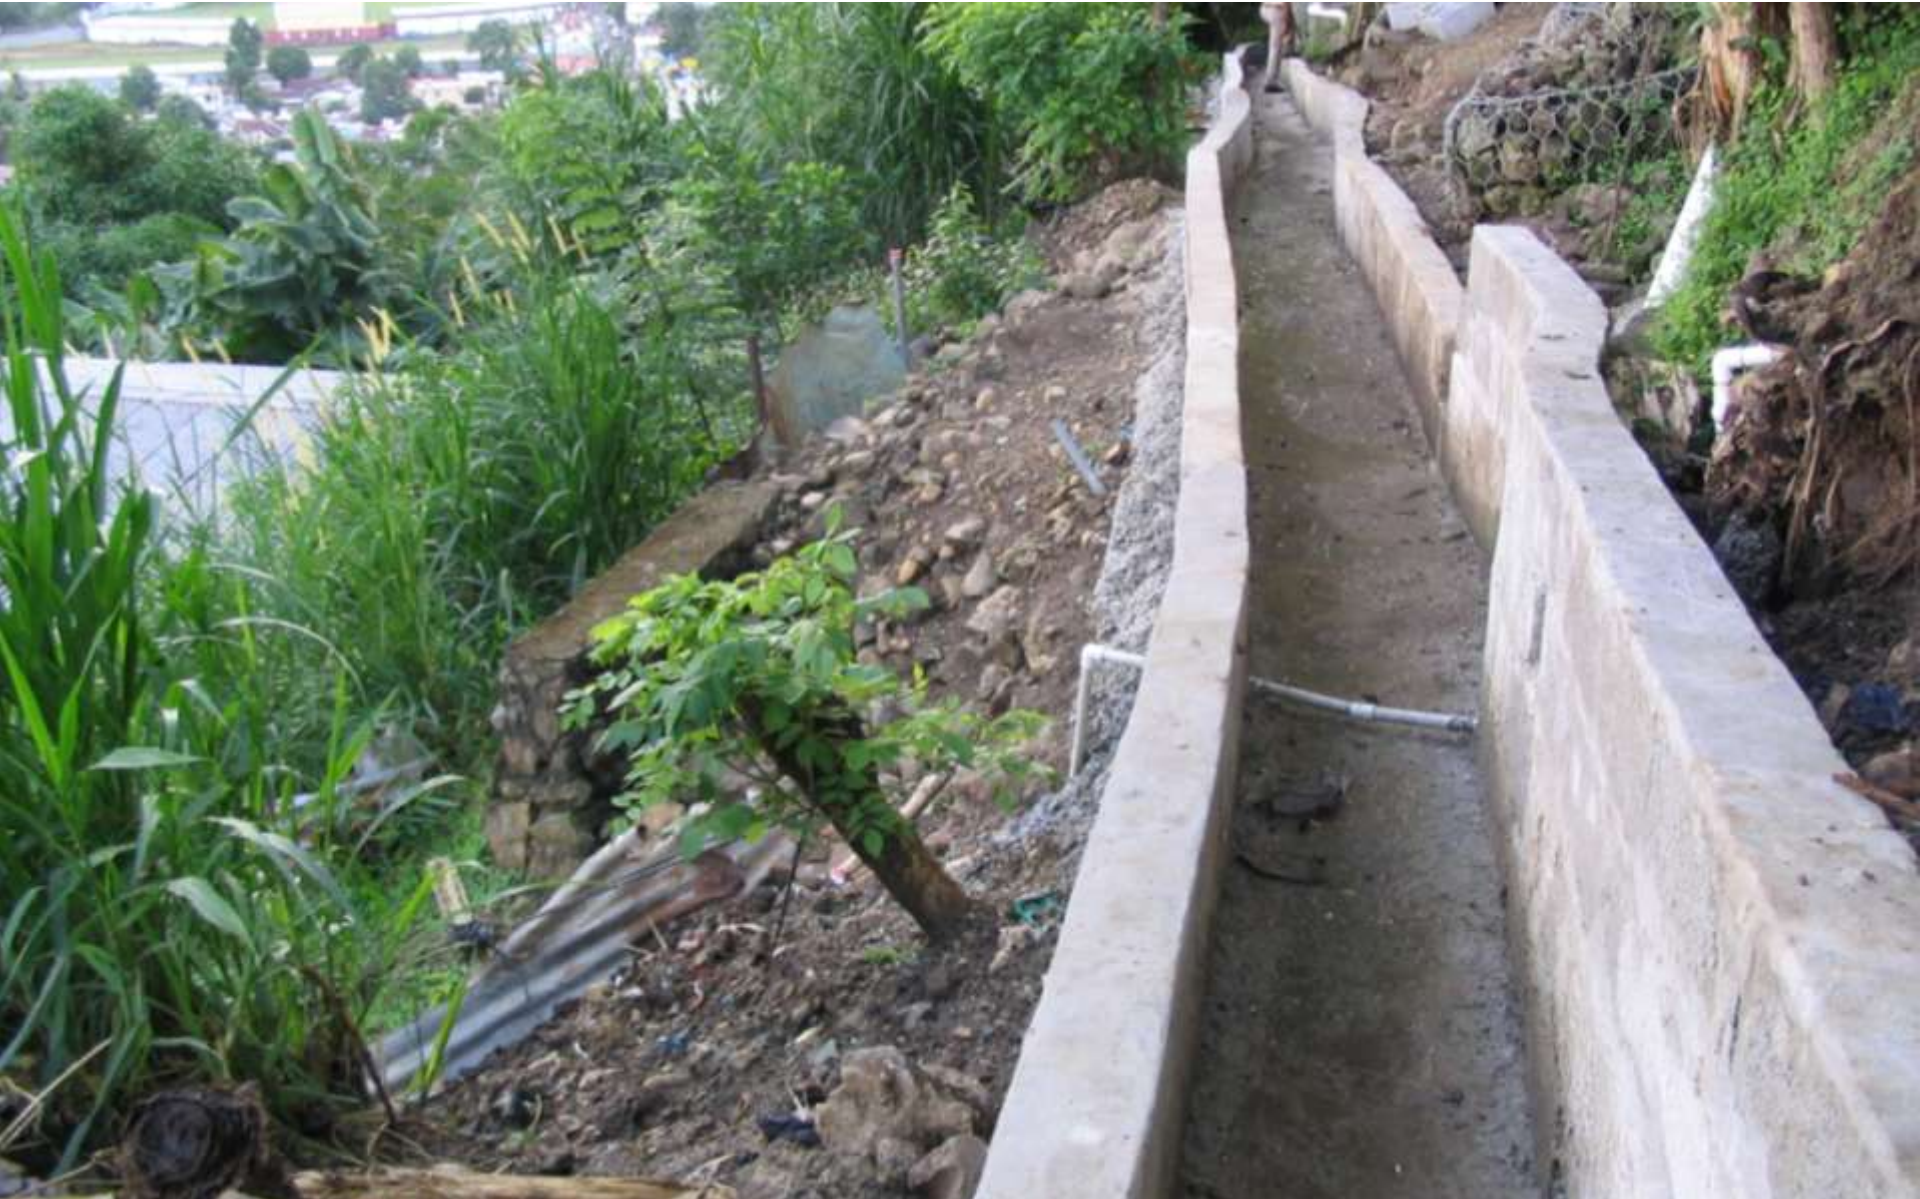
...that capture surface water
